## Customer Notification

# V850E/Dx3 - DJ3/DL3

## 32-Bit Single-Chip Microcontrollers

### Operating Precautions

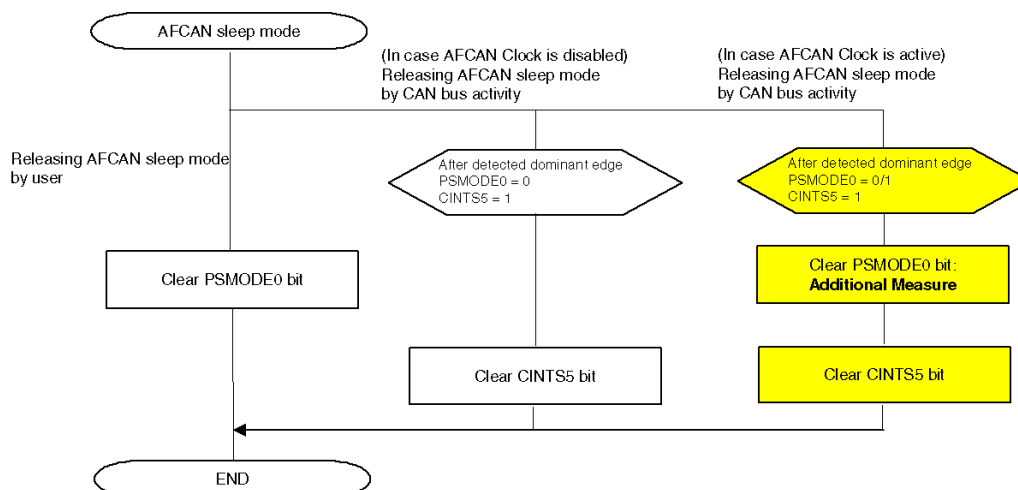
Figure: Additional Measures in case AFCAN clock is active when waking up

The following flowchart illustrates, how and whether additional measures have to be taken in software, to avoid the *wakeup dead time*.
